# World Housing Encyclopedia

## HOUSING REPORT

**Street front building with arcade at the first floor (contemporary construction)**

| <b>Country</b> | Taiwan |

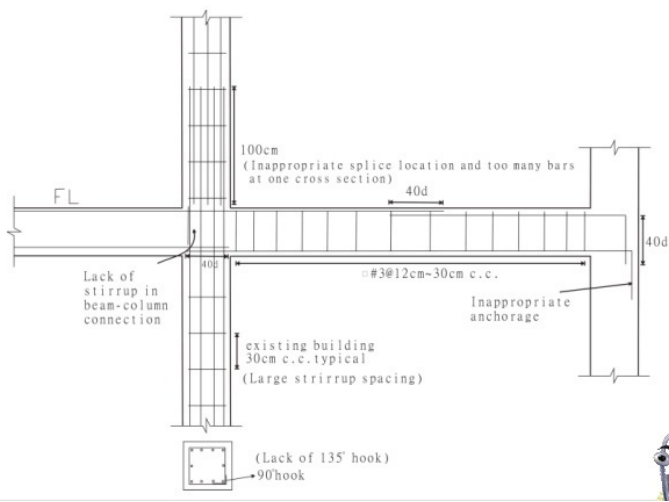
## Critical Structural Details - RC Frame Reinforcement Details

| <b>Seismic deficiency in frames</b> | - Column reinforcement is usually spliced at the top of the slab where the column bending moments are the largest (see Figure 7).As a result of this poor construction practice, seismic capacity of the columns is largely reduced. Majority of the buildings |

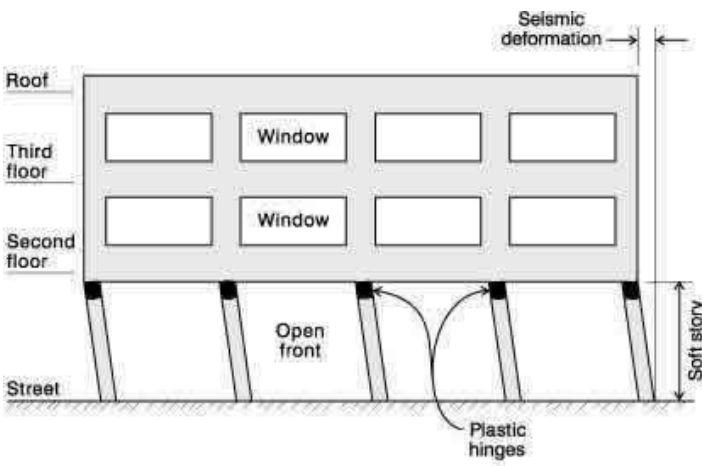
| <b>Seismic deficiency in roof and floors</b> | The open front at the bottom story is the most obvious configuration irregularity characteristic for this construction type. This feature creates undesirable soft-story and torsional effects, as illustrated in Figure 8. (Source: EERI 2001) |

**Seismic Deficiency: Soft-story deformation of open front at the street level**

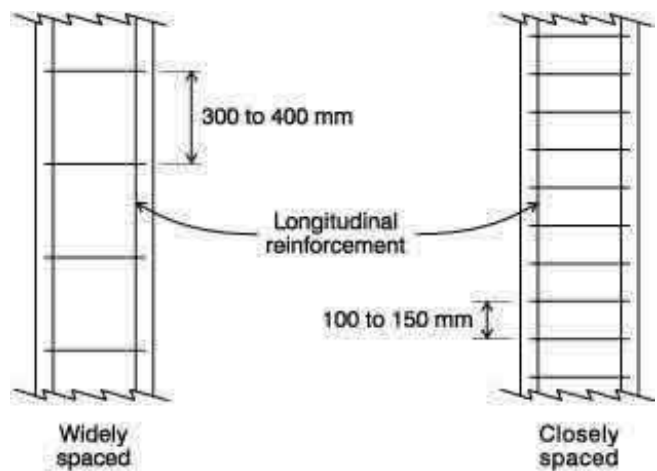
confinement reinforcement details consisting of widely spaced horizontal hoops, more than 300 mm apart, and 90 degree hooks. Usually, the lack of confinement reinforcement in the plastic hinge regions resulted in brittle failure. In some cases, hinge rotation caused buildings to permanently lean out of plumb. In other cases, buildings with no signs of earthquake damage remained standing next to the seemingly identical buildings that sustained the total collapse of entire bottom stories. 2) There was also widespread damage to the unreinforced brick partitions and perimeter walls. Although partitions are usually considered nonstructural elements, the collapse of or damage to unreinforced brick partitions represents a significant falling hazards, and it forced many people out of their homes. 3) Performance of this construction type in the earthquake was significantly influenced by the infill wall layout. Because brick infills significantly influence the structural characteristics and yet are not considered in the design, the seismic performance of this building type is highly unpredictable.

**Seismic Deficiency - Widely spaced hoop reinforcement (Source: EERI 2001)**

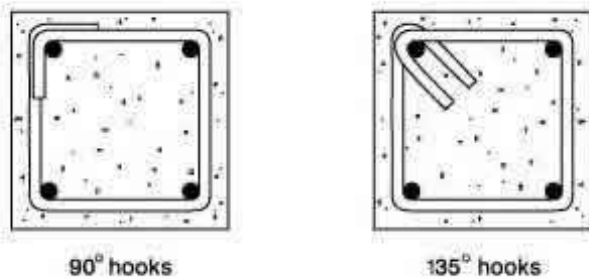
**Seismic Deficiency: Column ties -90 degree hook were used instead of 135 degree hooks (Source: EERI 2001)**

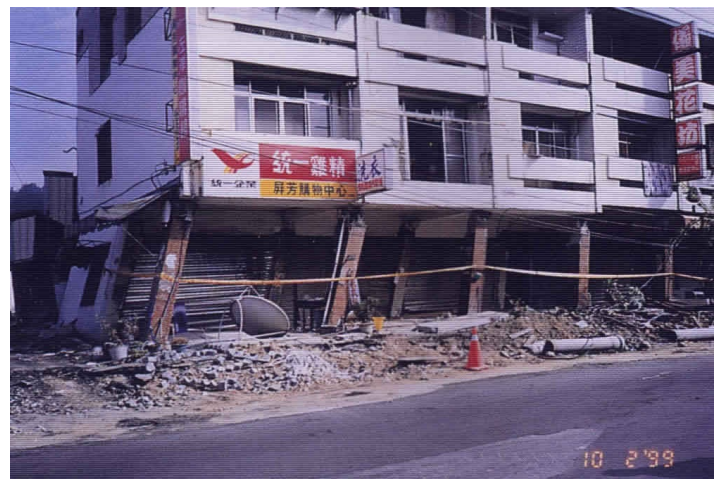
**A Photograph Illustrating Typical Earthquake Damage**

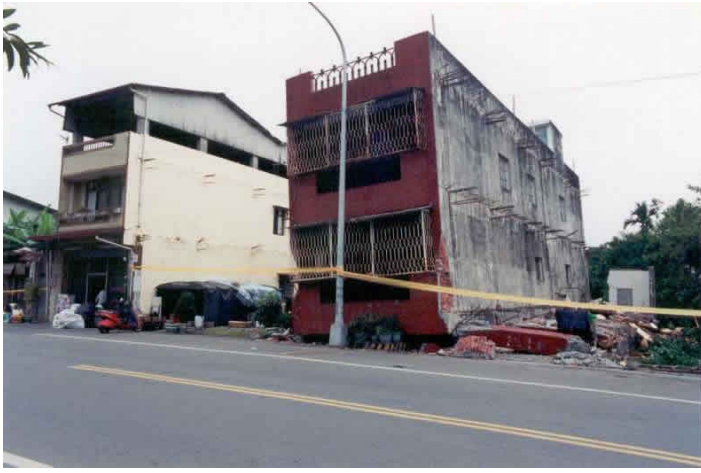
**Earthquake damage - Collapsed Three-story building in the 1999 Chi Chi earthquake (Source: EERI 2001)**

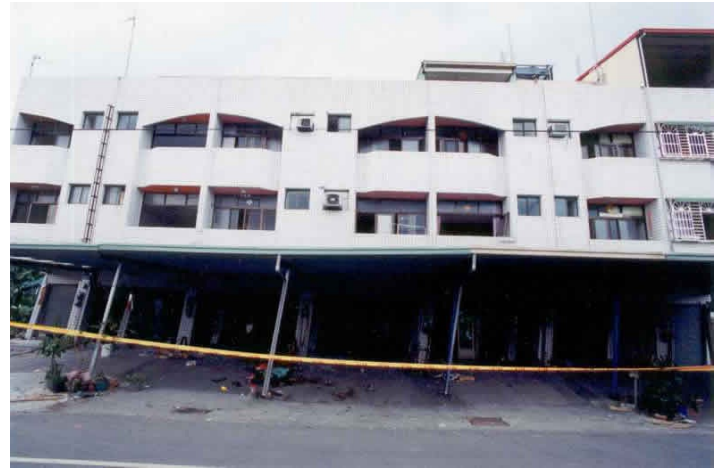
**Earthquake Damage - Partial Collapse of a Three-story building in the 1999 Chi Chi Earthquake (Source: EERI 2001)**

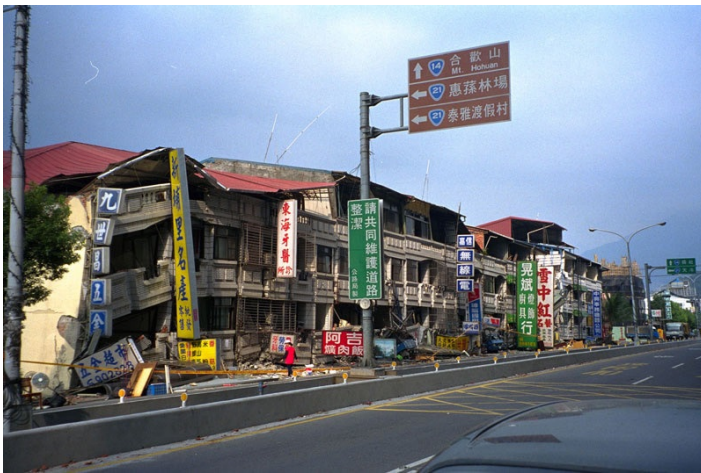
**Earthquake Damage - Pancake Collapse of an Entire City Block in the 1999 Chi Chi earthquake (Source: EERI 2001)**

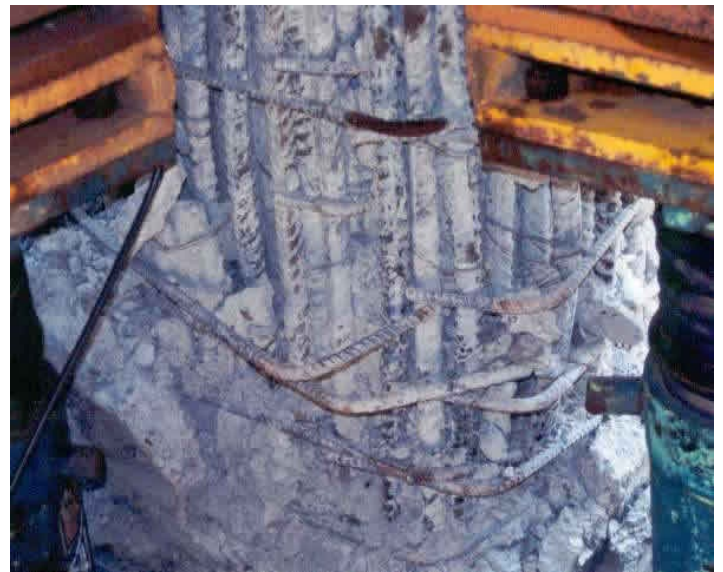
**Earthquake Damage - Opening of 90 degree column hooks in the 1999 Chi Chi earthquake (Source: EERI 2001)**

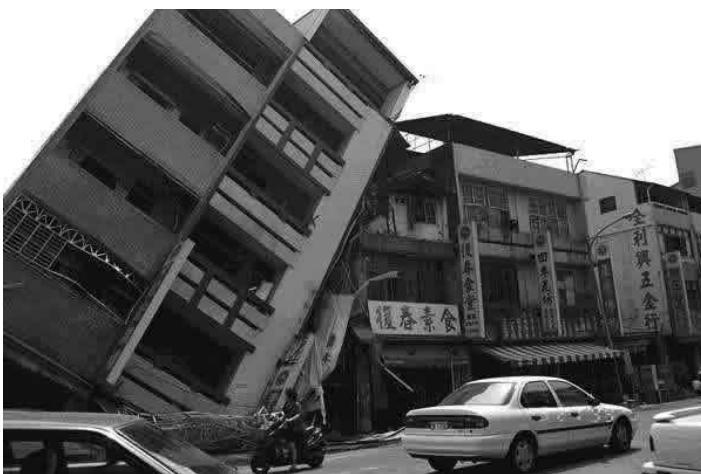
**Collapse of a Concrete Frame Building in the 1999 Chi Chi Earthquake (Source: EERI 2001)**
