World Housing Encyclopedia

HOUSING REPORT

Multi-story reinforced concrete frame building

Report#	15
Last Updated	
Country	Greece
Author(s)	T. P. Tassios, Kostas Syrmakizis, ,
Reviewers	Craig D. Comartin,

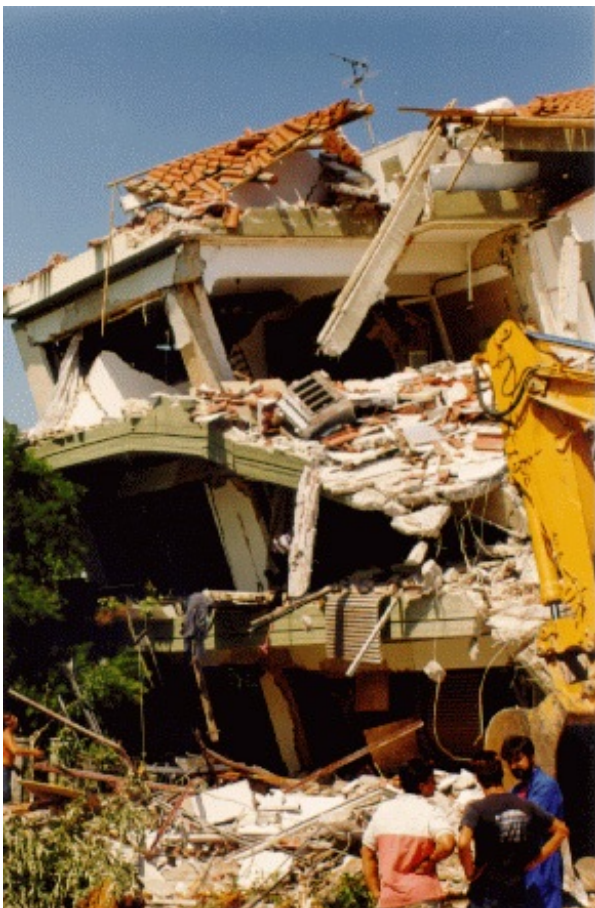
Typical Earthquake Damage (1999 Athens earthquake)

Cracking in shear walls of the elevator shaft (1999 Athens earthquake), see Figure 9. Joint failure in poorly constructed structures. Damage to column-beam joints due to bad concrete quality and insufficient reinforcement was observed in the 1999 Athens earthquake (EERI). In many cases, stirrup reinforcement was almost nonexistent (see Figures 7 and 8). Soft ground floor (where there is an absence of infill walls at the ground floor) may cause damage, leading to the development of collapse mechanisms. In the 1999 Athens earthquake, the damage occurred mainly to the joints, which were totally destroyed in a number of cases. As a result, the structural system became a mechanism, and large permanent horizontal displacements were observed. In some cases, collapse of the soft story was occasioned by P-d effect, combined with high vertical accelerations. (EERI)

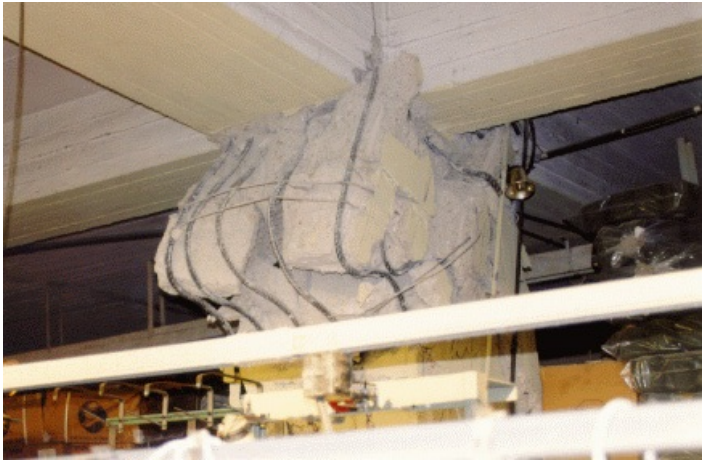
Earthquake Damage - Dislodged Column due to Soft Ground Floor Effect (1999 Athens earthquake)

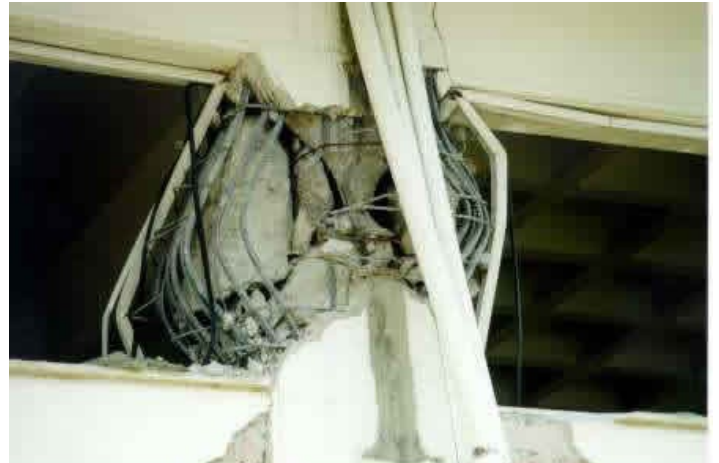
Typical Earthquake Damage-Column Failure (1999 Athens Earthquake)

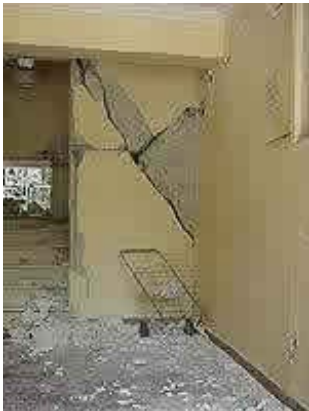
Failure of column, due to short column effect, of a 5-story building in Ano Liosia, which was built in 1997 according to the new Greek Seismic Code (1999 Athen earthquake); Source: ITSAK
