World Housing Encyclopedia

HOUSING REPORT

Timber stilt homes

Report#	165
Last Updated	
Country	Belize
Author(s)	Laura Redmond, Reginald DesRoches ,
Reviewers	Sugeng Wijanto ,

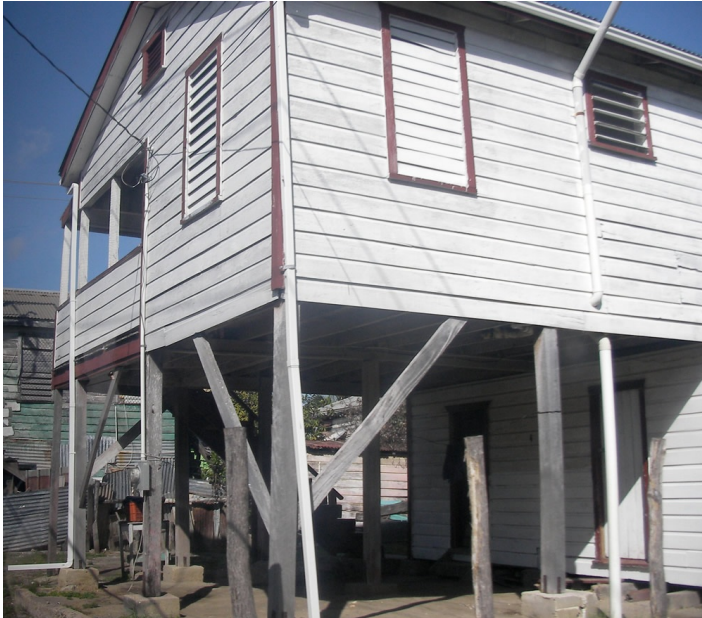
Typical wooden stilt home with a shed added underneath

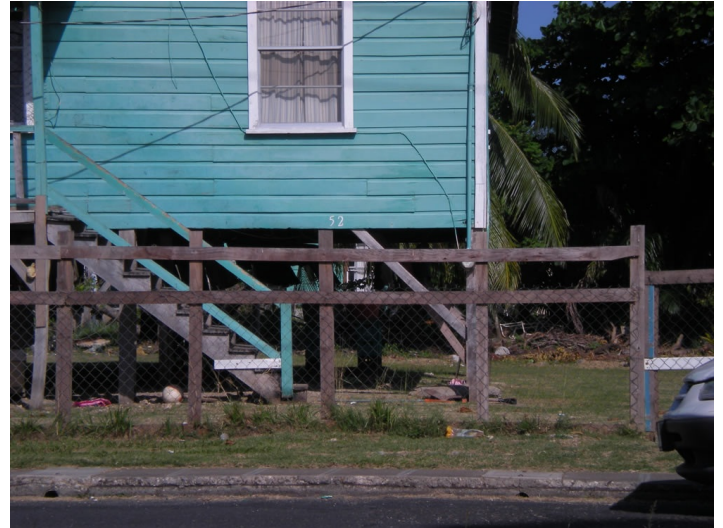
Close up of wood stilts

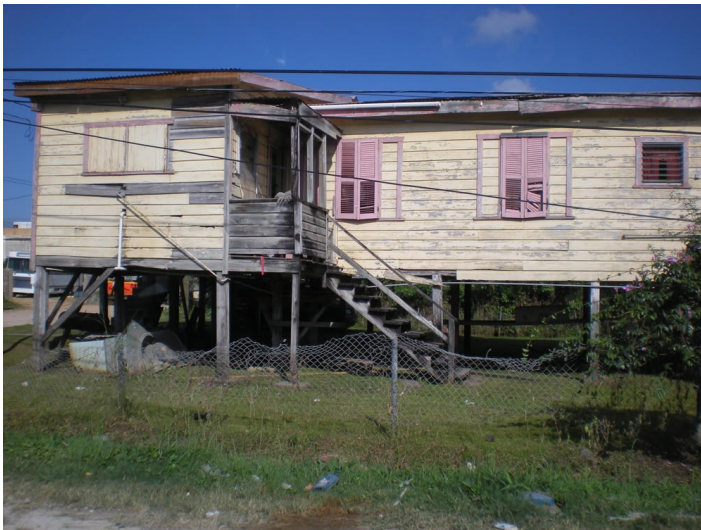
Wooden stilt houses may be poorly maintained, but still occupied

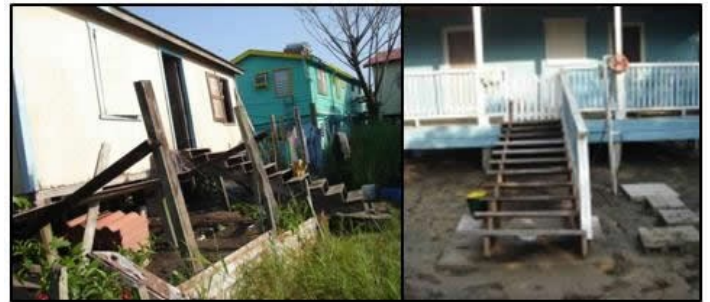
Stilt houses fell off their timber posts during the 2009 earthquake

Damage patterns observed in past earthquakes for this construction type	The past earthquakes listed here are only those over magnitude 6.0. The effects of the earthquakes are often less intense in Belize because the earthquake epicenters have been fairly shallow and far off the coast in the Caribbean Sea.
Additional comments on earthquake damage patterns	Overall damage patterns observed in past earthquakes for this type of construction included - (footing foundation): Houses sunk several feet into the ground (wood post stilts): Houses have fallen off their timber post stilts during a past earthquake (roof): No earthquake damage observed, but many roofs have been taken off during hurricanes.

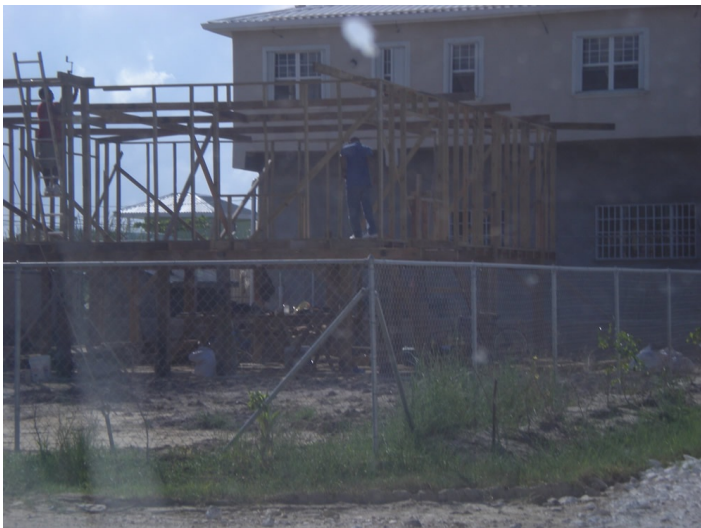
Construction of a timber stilt home
