World Housing Encyclopedia

HOUSING REPORT

Traditional adobe house

Report#	2
Last Updated	
Country	Argentina
Author(s)	Virginia I Rodriguez, Maria I Yacante, Sergio Reiloba,
Reviewers	Sergio Alcocer,

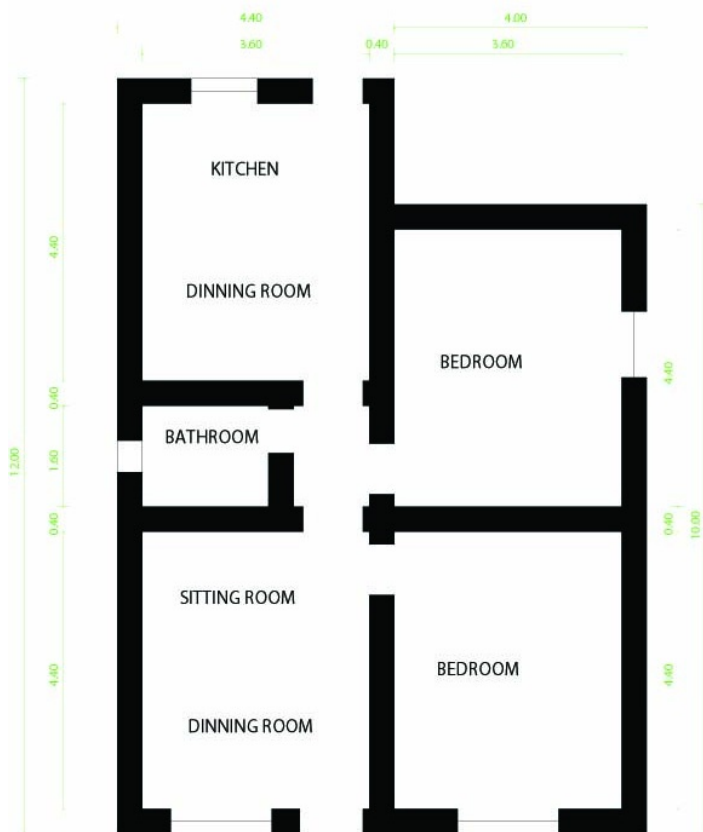
Plan of typical building

Additional comments on plan shape	The typical shape of a building plan for this housing type is rectangular.
Typical plan length (meters)	12
Typical plan width (meters)	8.4
Typical story height (meters)	3
Type of Structural System	Masonry: Earthen/Mud/Adobe/Rammed Earth Walls: Mud walls with horizontal wood elements
Additional comments on structural system	The vertical load resisting system is adobe block walls. The earthquake-resistant system consists of adobe block walls of 40 cm thickness, which generally meet the quality standards and architectural requirements (small openings, heights shorter than 3 m). In general, the roofs are light (weight less than 150 kg/sq m). On the upper part of the wall, there is a reinforced concrete bond beam, and on the bottom there are foundations and plinth structure.
Gravity load-bearing & lateral load-resisting systems	40-cm-thick block walls joined using mud mortar.

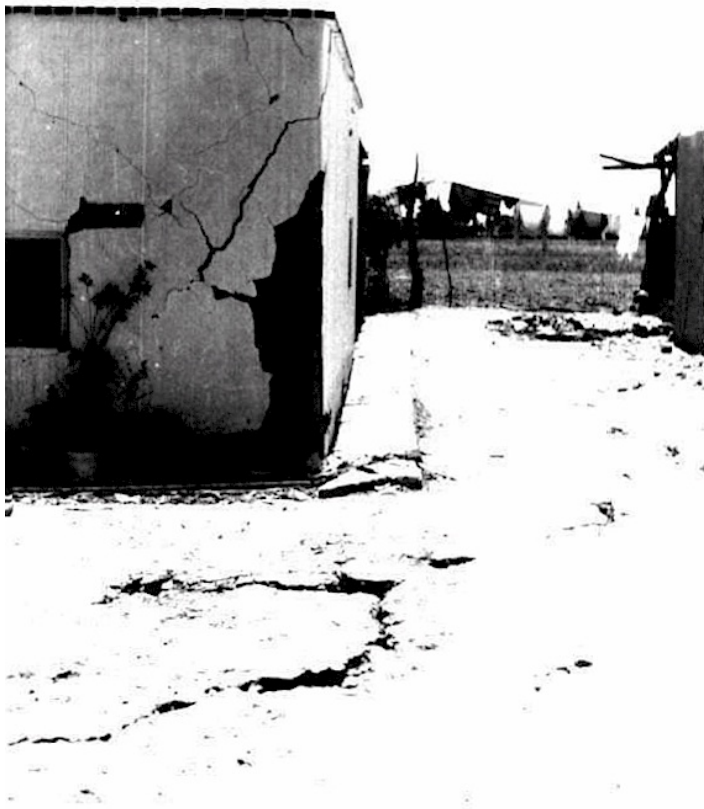
Photograph illustrating typical earthquake damage

<p>Damage patterns observed in past earthquakes for this construction type</p>	<p>In general, during the 1977 earthquake, the adobe block construction built in Caucece using the standards of 1948, suffered moderate damage (economically repairable); those built in the capital city of San Juan, under the same standards, were not damaged at all. Traditional adobe block houses, built without any kind of earthquake-resistant requirements, were seriously damaged during the same earthquake.</p>
<p>Additional comments on earthquake damage patterns</p>	<p>In the Capital city of San Juan, located at approximately 100 km distance from the epicenter, the intensity was between VII MMI and VIII MMI . It is important to mention that a wide area of about 1000 km² experienced liquefaction.</p>

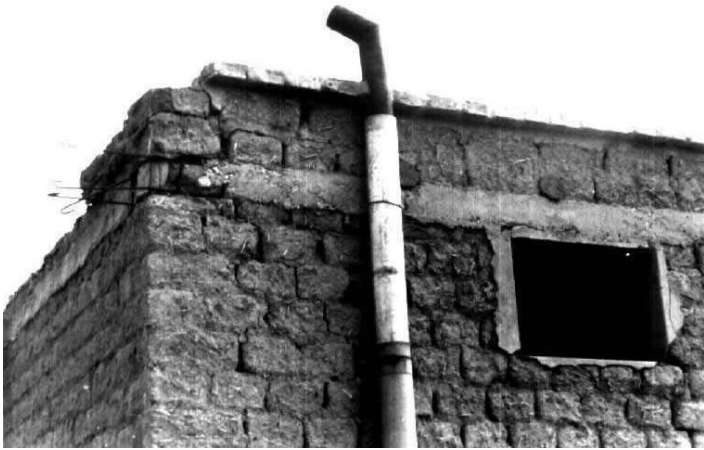
Photograph illustrating typical earthquake damage
