World Housing Encyclopedia

HOUSING REPORT

Unreinforced brick masonry walls with pitched clay tile roof

Report#	22
Last Updated	
Country	India
Author(s)	Amit Kumar,
Reviewers	Ravi Sinha ,

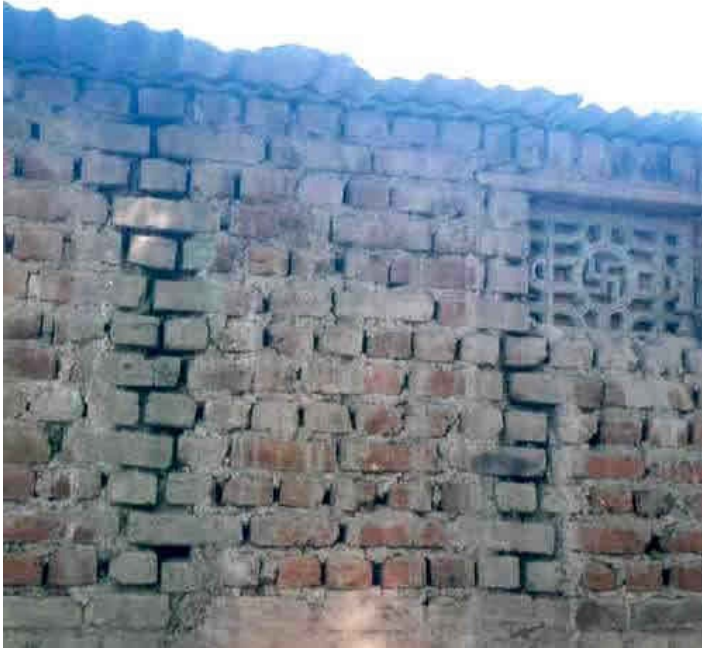
Critical Structural Details: Elevation of Brick Masonry Wall in Mud Mortar (Source: Svetlana Brzev)

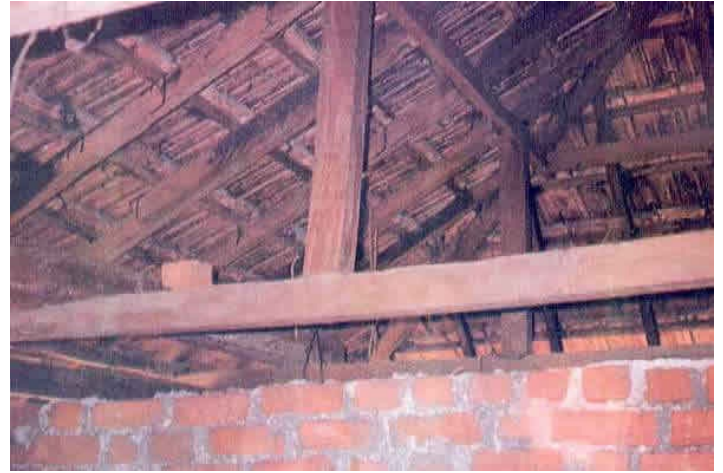
Critical Structural Details: Good Quality Roof Construction (Source: GOM 1998)

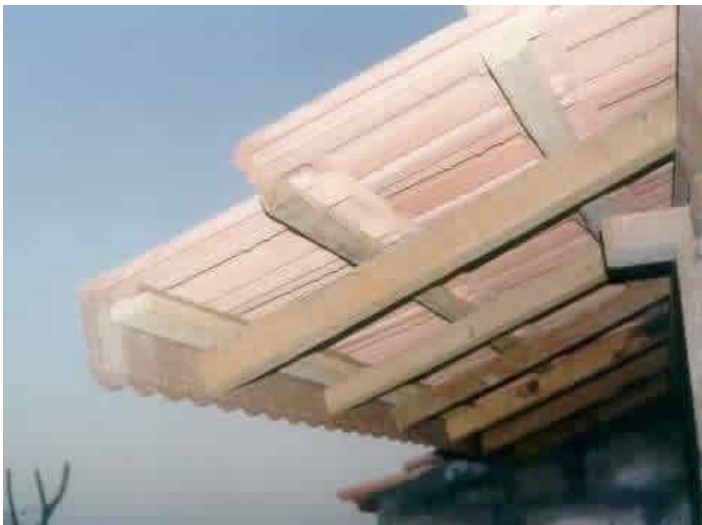
Critical Structural Details: Mangalore Tile Roof Construction (Source: Sudhir K. Jain, IIT Kanpur)

Generally the roofing elements are placed at the top of the wall without proper connection to the wall. The roofing elements such as purlins, rafters and ties rods are also not properly interconnected.

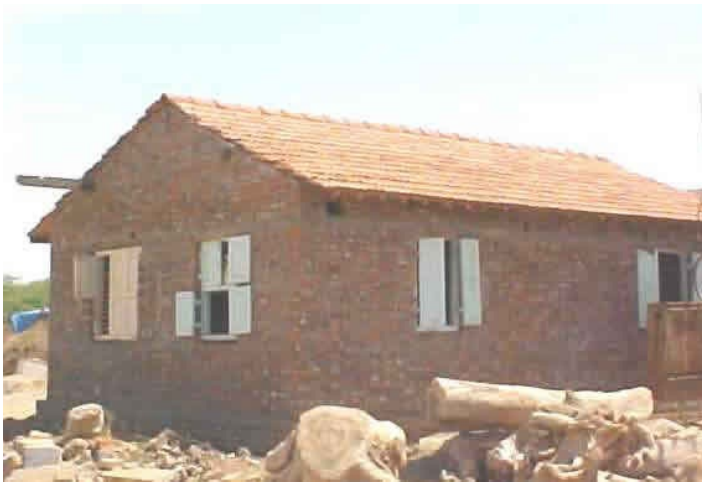
Key Seismic Resilient Features: RC Lintel Band and Good Quality Brick Masonry Construction (Source: Sudhir K. Jain, IIT Kanpur)

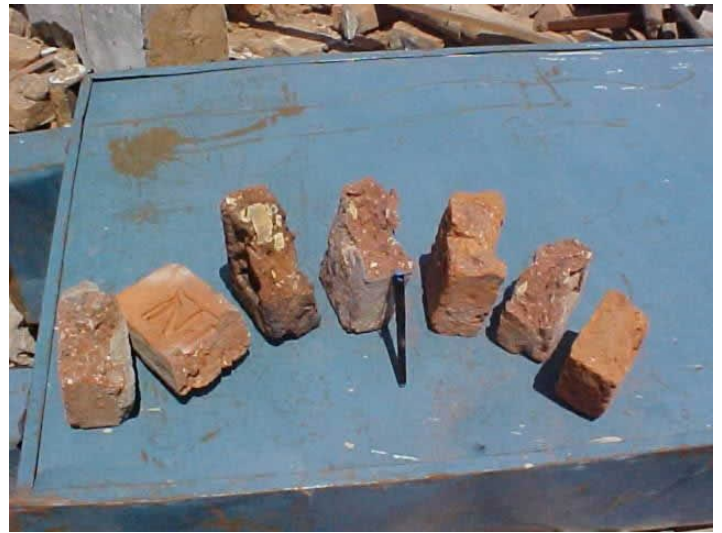
Construction Deficiency: Poor Quality Bricks (Source: Sudhir K. Jain, IIT Kanpur)

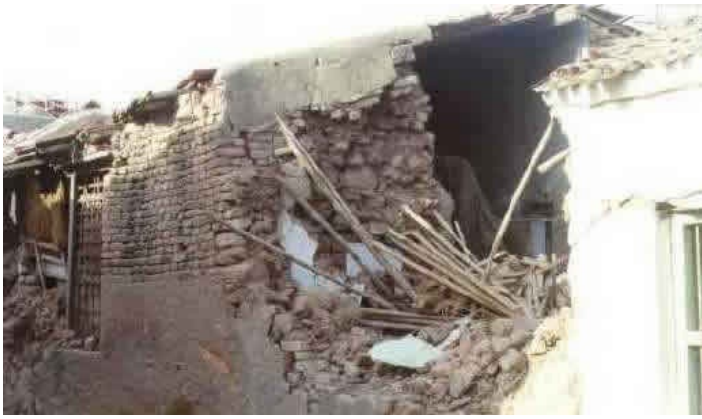
Typical Earthquake Damage - Wall Collapse Due to Poor Quality Brick Construction and Poor Inadequate Wall Connections in the 2001 Bhuj Earthquake (Source: IIT Powai 2001)

earthquake. In general, these structures performed poorly in the earthquake. In the epicentral region, several buildings of this type suffered total collapse of the walls resulting in the death and injury to large number of people. In masonry buildings with pitched roof, the roof tiles performed very poorly. In most cases, the roof tiles were damaged and in several instances, the tiles slid off the roof. Most of the dwellings have experienced failure of roofing tiles inside the house and rafters supporting the roof truss have also failed in some cases (Source: IIT Powai 2001).

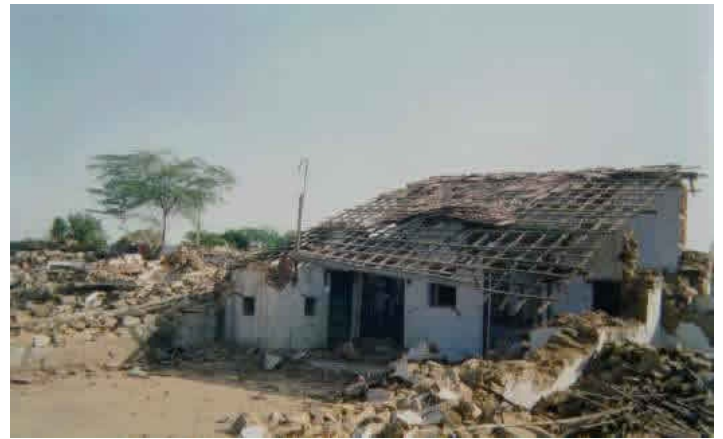
Failure of a Residential Building, Chobri Village near Bhachau, 2001 Bhuj Earthquake (Source: IIT Powai 2001)

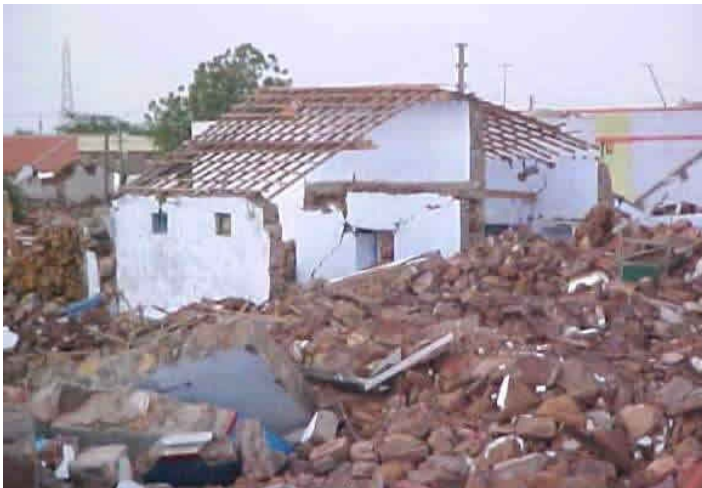
Typical Earthquake Damage: Collapse of Roof and Walls of a Brick Lime Mortar House in the 2001 Bhuj Earthquake (Source: Sudhir K. Jain, IIT Kanpur)
