# World Housing Encyclopedia

## HOUSING REPORT

### Semi-rigid steel frame with "Khorjinee" connections

<b>Report#</b>	26
<b>Last Updated</b>	
<b>Country</b>	Islamic Republic of Iran
<b>Author(s)</b>	Behrokh Hosseini Hashemi, Mohsen Ghafory Ashtiany,
<b>Reviewers</b>	Farzad Naeim ,

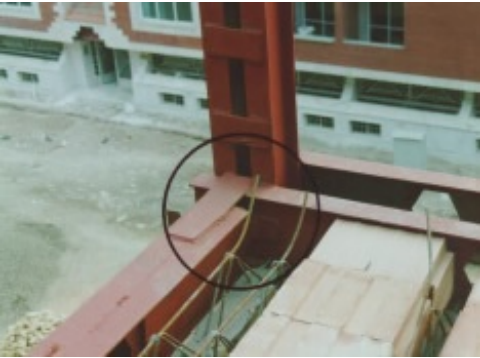
**A seismic deficiency: wrong connection detail**

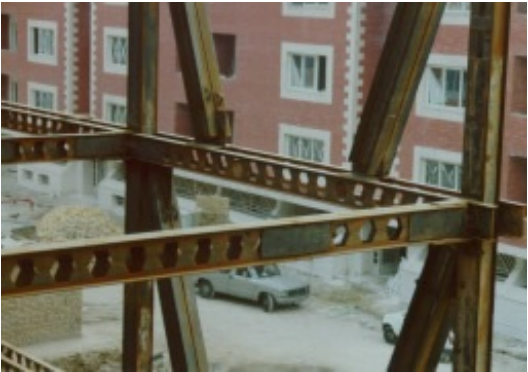
**Seismic deficiency-use of undefined bracing system**

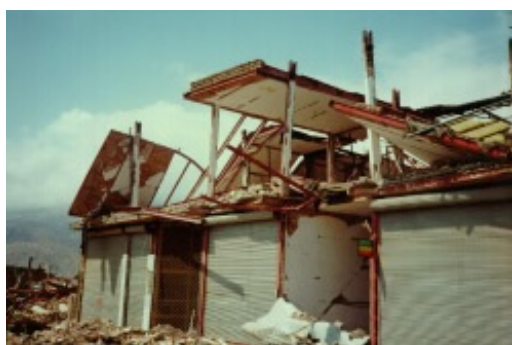
***Building damage in the 1990 Manjil earthquake-collapse caused by the connection failure***

<b>Damage patterns observed in past earthquakes for this construction type</b>	
<b>Additional comments on earthquake damage patterns</b>	Walls: Out of plane collapse, Classical X shear cracking. Frames: Buckling of the storey. Roof/Floor: Total/partial collapse. Connections: Excessive rotations, shear failure of the welds, unsitting.

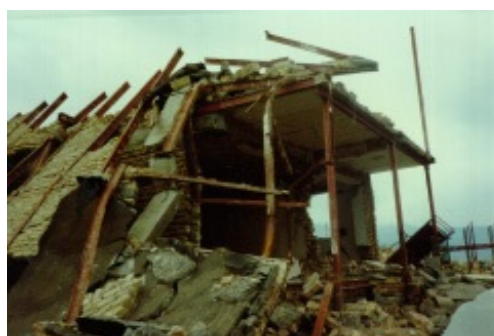
***Building damage in the 1990 Manjil earthquake-collapse caused by the connection failure***

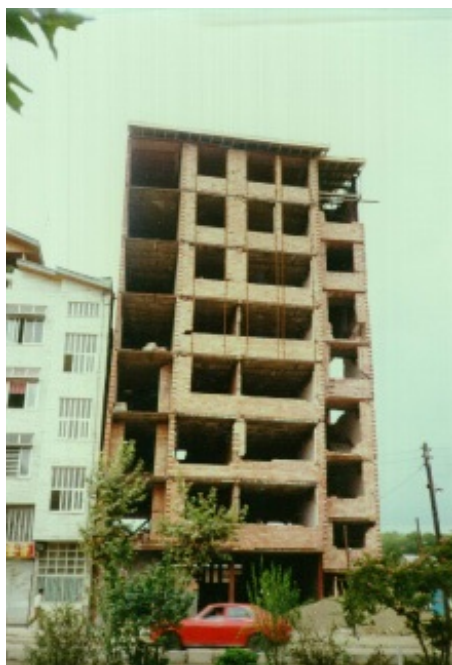
***Minor damage due to pounding between two adjacent buildings in the 1990 Manjil earthquake***

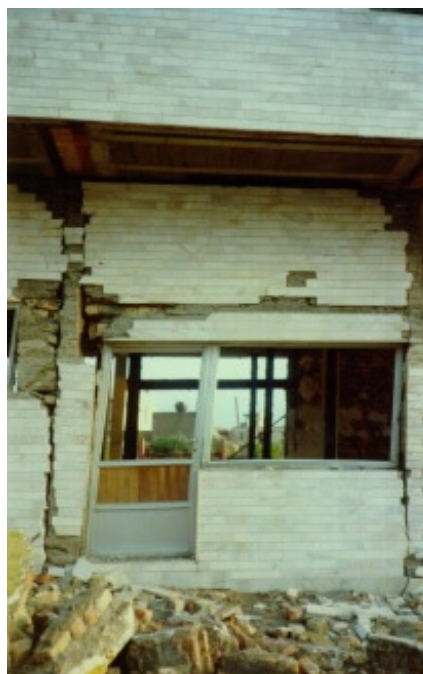
***Failure due to soft story behavior in the 1990 Manjil earthquake***

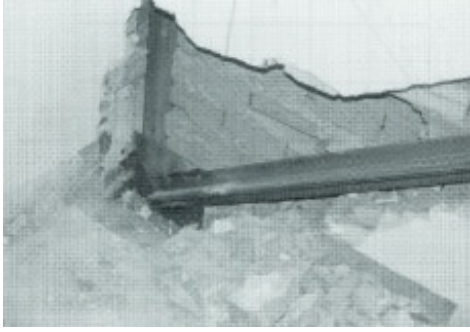
**Illustration of Seismic Strengthening Techniques-New Braces Added to the Main Frame**

Structural Deficiency	Seismic Strengthening
Steel frame	Add diagonal steel bracings as required (high cost/high effectiveness/simple construction)
Connections	Strengthening connections by adequate and proper welding (medium cost/medium effectiveness/simple construction)
Foundations	At the location of the new bracing, strengthening of foundation is essential (high cost/medium effectiveness/complex construction)
New Construction	Steel frame: Design steel frame for gravity load and steel bracing for lateral resistant system (medium cost/medium effectiveness) Connections: Provide proper details for connections (low cost/high effectiveness) Foundations: Proper design (low cost/high effectiveness)
