World Housing Encyclopedia

HOUSING REPORT

Adobe house

Report#	52
Last Updated	
Country	Peru
Author(s)	Cesar Loaiza, Marcial Blondet, Gianfranco Ottazzi,
Reviewers	Sergio Alcocer,

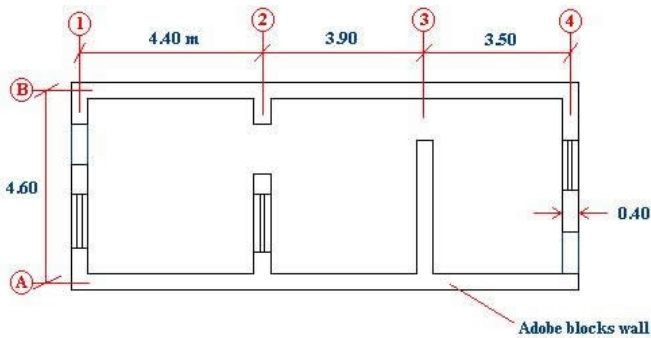
Typical House Plan

Plan of a Typical Building

Typical Plan Dimensions: Length varies from 8 to 10 m. Width varies from 5 to 10 m. Typical Story Height: In the coastal region, the typical story height is 4.0 m; in the highland region the height is 3.0 m. Typical Span: Span varies from 3 to 6 m. The typical storey height in such buildings is 4.0 meters.

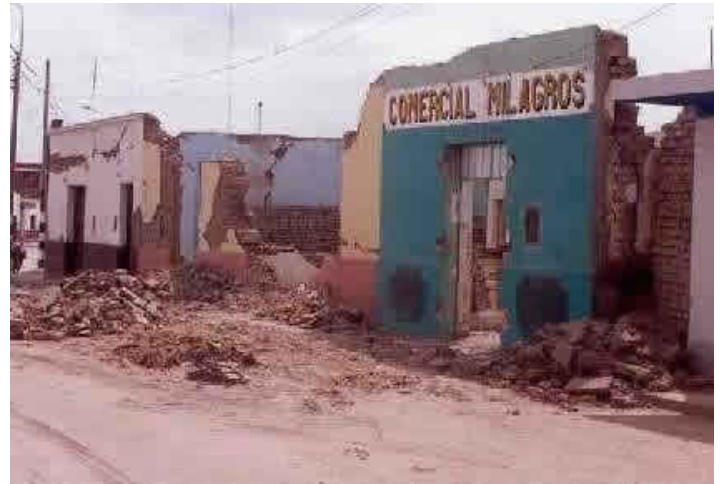
Key Seismic Deficiencies - Adobe Wall Failure Due to Out-of-Plane Seismic Forces

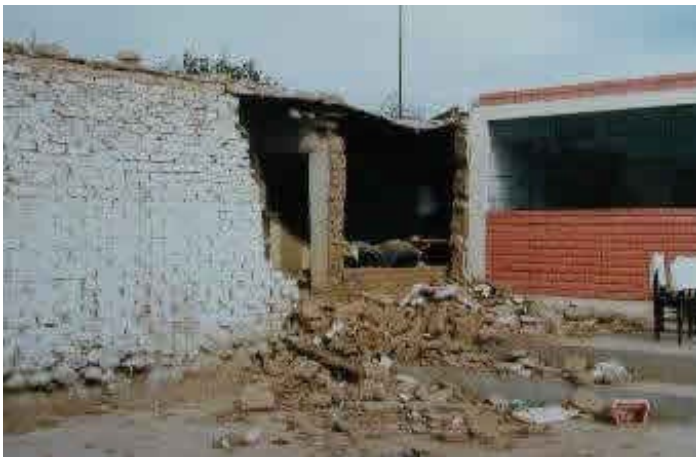
Key Seismic Deficiencies - Wall Damage Due to Inadequate In-Plane Seismic Resistance

Wall shear cracking

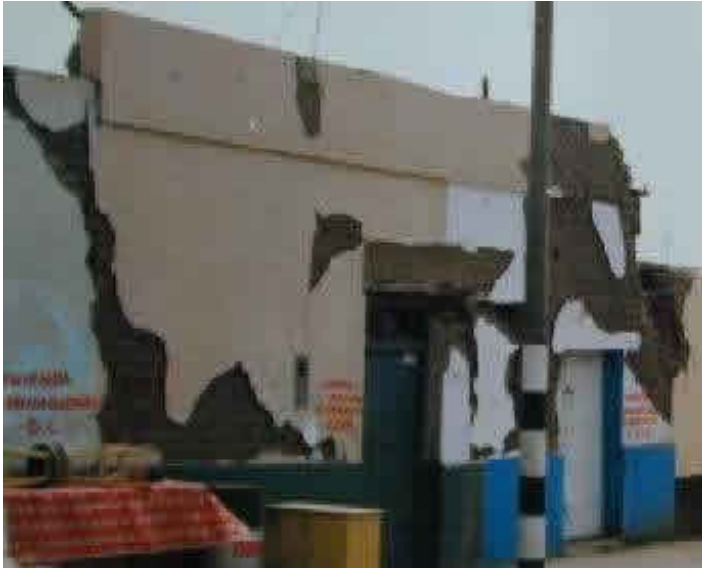
A Photograph Illustrating Typical Earthquake Damage (November 1996 Nasca Earthquake)

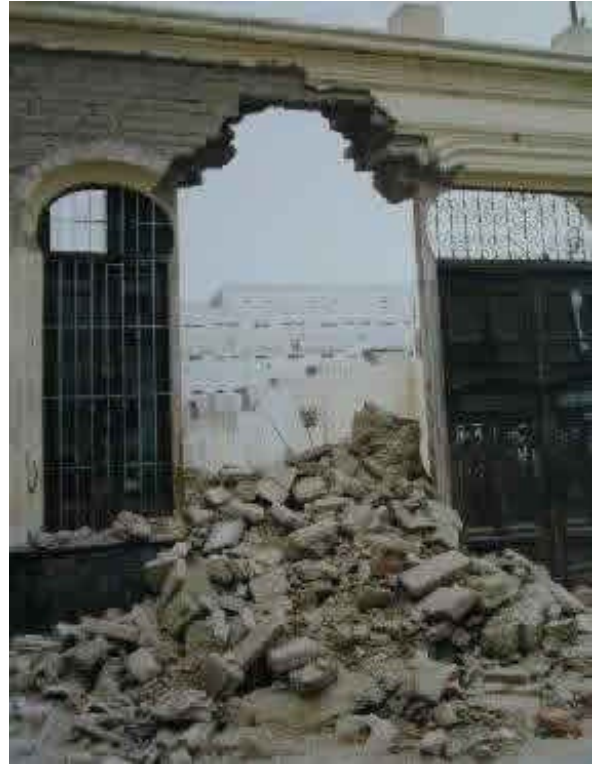
A Photograph Illustrating Typical Earthquake Damage (November 1996 Nasca Earthquake)

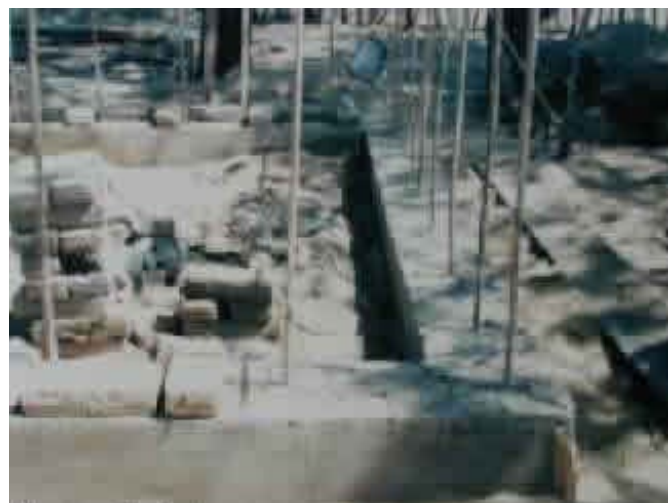
Seismic Strengthening - Construction of Wooden Beams atop the Adobe Walls

Structural Deficiency	Seismic Strengthening
Adobe walls- Lack of confinement	Adobe walls are confined with reinforced concrete tie columns and beams. Concrete columns are cast against the serrated endings of adobe walls. This is a very good seismic strengthening system, however it could be expensive for owners.
Lack of integrity- adobe walls	A wood beam is cast atop the walls, keeping them united during an earthquake. It is an inexpensive system. (see Figure 10)
Adobe walls-poor in-plane and out-of-plane resistance	A steel mesh fixed with metal plates is installed to strengthen the adobe walls. The mesh is applied on both wall surfaces and at the wall corners. This is a very effective and inexpensive strengthening system, developed at the Catholic University of Lima.
(New Construction): Improved integrity of adobe walls	A wooden beam is cast atop the walls, keeping them united during an earthquake. Rectangular wood beams are used as lintels. (see Figure 10)
