World Housing Encyclopedia

HOUSING REPORT

Popular, non-engineered urban housing on flat terrain

Report#	67
Last Updated	
Country	Venezuela
Author(s)	Argimiro Castillo Gandica, Francisco Lopez Almansa,
Reviewers	Sergio Alcocer,

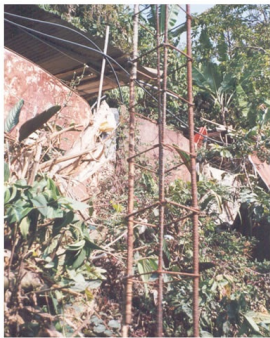
Ties and Stirrups widely spaced, 90 ° Anchorage hooks

Inexistent Collar Beam

Inadequate connection between floor and frames

Earthquake-resilient features in walls	
Seismic deficiency in frames	-Stirrup and tie spacing is not compliant to recommendations of less than $d/2$ spacing in beams and $d/4$ in columns, neither in beams nor in columns. Spacing is regular throughout all members and is usually d or more. Anchorage hooks into member cores are g
Earthquake-resilient features in frame	
Seismic deficiency in roof and floors	Roof may not be considered as a rigid diaphragm due to the lack of adequate connectivity within its elements and with the walls (absence of a collar beam on top of walls at this level).Connections between floor and frames must be inspected to guarantee adequate linking and load transmission.
Earthquake resilient features in roof and floors	
Seismic deficiency in foundation	
Earthquake-resilient features in foundation

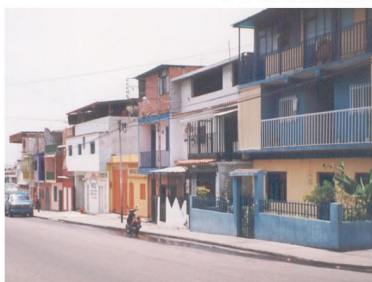
Adjacency and height differences

An Illustration of Key Seismic Features

Inexistent seismic detailing features in reinforced concrete works. Connections between floors and structural frames do not guarantee lateral force transmission and may induce displacement of slabs with respect to the frames generating damage to columns. Parapets in uppermost levels represent a dangerous collapsible feature. The absence of collar beams and horizontal reinforcement in uppermost walls may produce out-of-plane inertial loads. Gap between adjacent buildings (not greater than 10.0 cm.) creates risk of pounding effect.

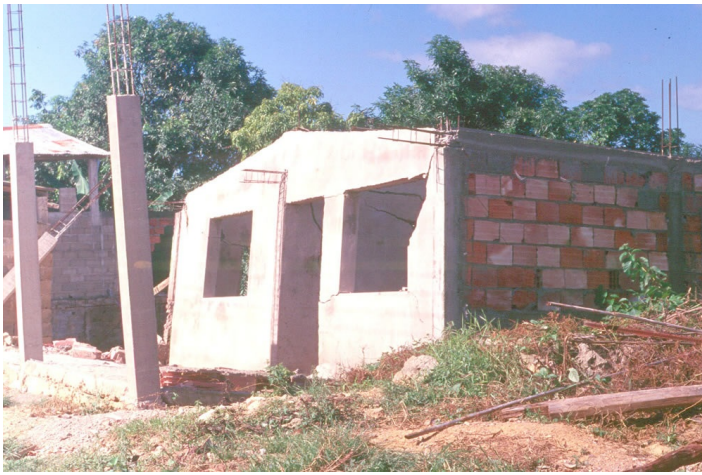
***A Photograph Illustrating Typical Damage
(1997 Cariaco earthquake)***

Damage patterns observed in past earthquakes for this construction type	See Figure 6.
Additional comments on earthquake damage patterns	<p>Wall: Cracks in walls, parts of walls collapse, great cracks in windows and around doors. Frame: Shear failure in connections between columns and beams, and between columns and foundations, excessive lateral displacements, cracking and spalling concrete columns due to inadequate confinement. Roof/Floors: Roof- great movements may be generated in roofs, total dismantlement and consequent collapse may occur. Floors- great movements may inflict damage in confinement and walls. Other: Column failure at level where slabs of neighboring construction pounds.</p>
