World Housing Encyclopedia

HOUSING REPORT

Traditional rural house in Kutch region of India (bhonga)

Report#	72
Last Updated	
Country	India
Author(s)	Madhusudan Choudhary, Kishor Jaiswal, Ravi Sinha,
Reviewers	Mauro Sassu,

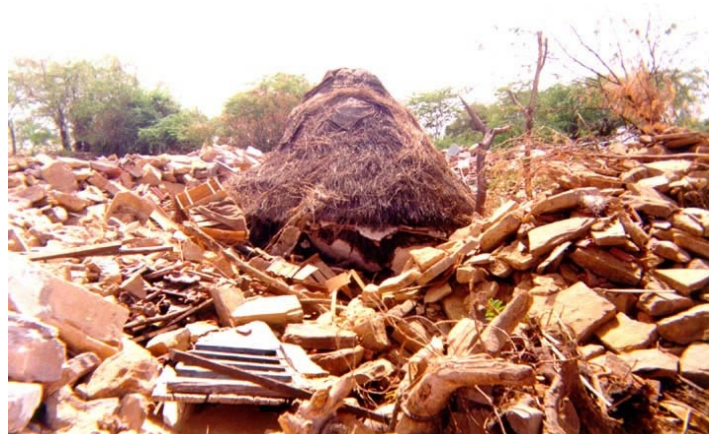
A Photograph Illustrating Typical Earthquake Damage (2001 Bhuj earthquake)

Minor damage for walls constructed with cement mortar and significant damage for walls constructed with mud mortar were observed after Bhuj earthquake. Only minor damage to the roofs were observed during the Bhuj earthquake, even for Bhongas whose walls had totally collapsed. The roof was able to maintain its structural integrity due to its light weight and weak connection between the roof and the wall.

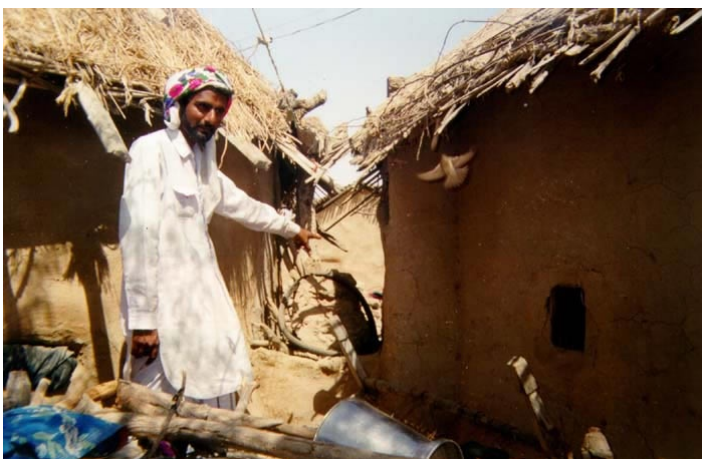
Illustration of Indigenous Seismic Strengthening Techniques

Structural Deficiency	Seismic Strengthening
Low resistance to lateral loads	Providing seismic bandage between lintel and roof levels on both outside and inside of the wall.
Weak roof support system	Providing additional joists to transfer roof load to the cylindrical walls.
Weak roof support system	Providing new vertical post adjacent to walls (on the outside) to support the roof joist.
New Construction: Low resistance to lateral loads	Using cement mortar and stone or burnt brick masonry for walls; Constructing seismic bands at lintel and roof levels to enhance wall stiffness to lateral loads and to also improve shear resistance near corner of openings
New Construction: Weak roof	Providing vertical post adjacent to walls (on the

support system	outside) to support roof joints; Providing several joists to transfer roof load to the cylindrical walls or vertical posts.
Additional comments on seismic strengthening provisions	
Has seismic strengthening described in the above table been performed?	No, seismic strengthening of Bhongas has not been carried out.
Was the work done as a mitigation effort on an undamaged building or as a repair following earthquake damages?	Not applicable.
Was the construction inspected in the same manner as new construction?	No formal structural inspection is done for either new or rehabilitated constructions.
Who performed the construction: a contractor or owner/user? Was an architect or engineer involved?	In these rural constructions, technically trained personnel are seldom available. Most constructions are carried out by skilled or semi-skilled persons only.
What has been the performance of retrofitted buildings of this type in subsequent earthquakes?	No data is available. However, new constructions with earthquake-resistant features performed very well compared to Bhongas without any earthquake-resistant features. The performance of these Bhongas was comparable to that of RCC frame structures in the epicentral region.
