HOUSING REPORT

multistory tower masonry with stone pillars and wood or arched beams (Casa Torre)

Report#	113
Last Updated	
Country	Italy
Author(s)	Mauro Sassu, Chiara Cei,
Reviewers	Svetlana N. Brzev,

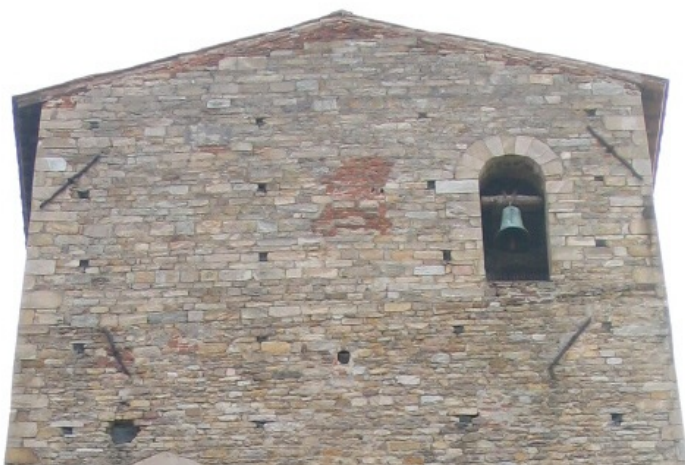
Opposite walls are connected by the use of tie-rods, with evident improvement in seismic behavior.

Structural Deficiency	Seismic Strengthening
Transverse connection between opposite walls	Steel tendons: grid wood floor frame
Vertical settlement	Reinforcement of the foundations with RC tub-fix micropiles

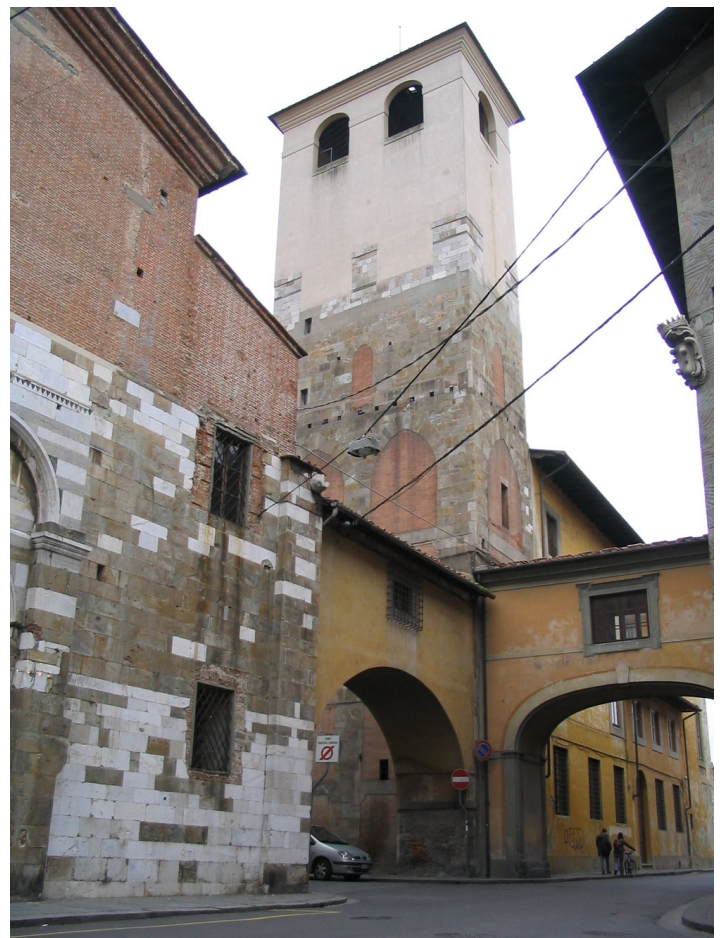
"Torre della Verga d'oro." Structural reinforcements: two large arched openings supporting horizontal forces at the base of the tower have been infilled by clay units.
