HOUSING REPORT

Vivienda de Minifalda (Wooden houses with heavy bases)

| Country | Nicaragua |

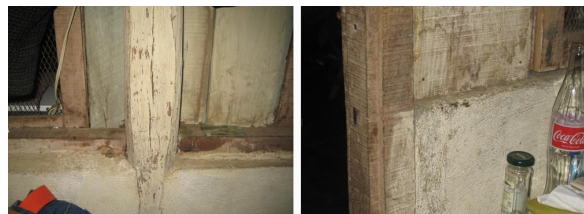
Detailing of the transition zone between the masonry base and upper wooden part of the wall.

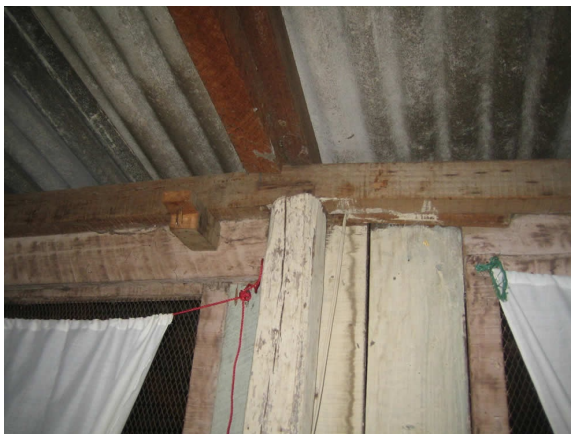
Roof made of asbestos sheets supported by wooden beams which loosely rest on the wooden walls.
