World Housing Encyclopedia

HOUSING REPORT

Precast, prestressed concrete frame structure with concrete shear walls

Report#	68
Last Updated	
Country	Serbia
Author(s)	Radovan Dimitrijevic, ,
Reviewers	Svetlana N. Brzev,

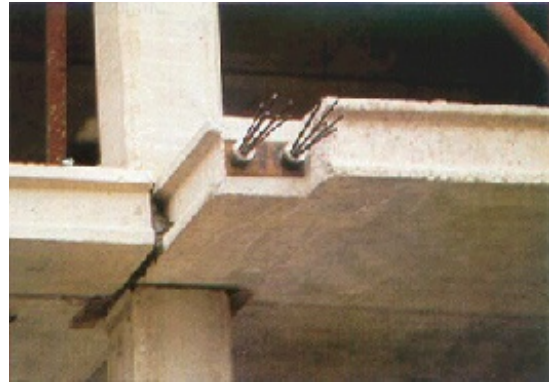
Details of a typical post-tensional slab-column connection

<p>Additional comments on structural system</p>	<p>thick) enclosed with the two adjacent columns. The columns are provided throughout the building height. As elements of the shear wall, columns carry additional axial load (tension/compression) due to the bending moment. The concrete wall panels are subjected to shear effects. It is very important to ensure the continuity of shear walls in both directions throughout the height of the building. The concrete wall panels are usually cast in-situ. However, in some cases precast panels have been used. Generally, the concrete frame itself is able to sustain the lateral force effects. However, because the structure is too flexible, excessive lateral movements would have detrimental effects on the performance of nonstructural elements, e.g., the facade, partitions, installations. The shear walls therefore have a role in increasing the lateral stiffness of the structure and in limiting lateral deflections to the acceptable level. The main feature of this building type of space frame is the high load-bearing capacity of the prestressed floor-column joints. This capacity is based on the friction developed between these two concrete elements after the prestressing is completed. A number of tests were performed, in which column-slab joint models were subjected to static or quasi-dynamic loading. The tests have revealed that failure occurs in the connected elements (i.e., in the slab) and not in the joint itself. Typical floor-column joints are illustrated in FIGURE 4A.</p>

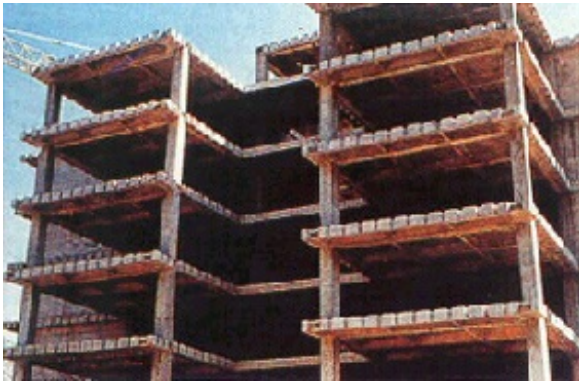
Details of an IMS building under construction showing cantilevered balcony slabs

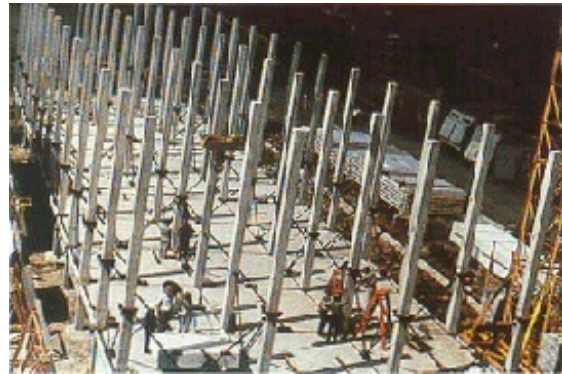
IMS building under construction showing columns under construction

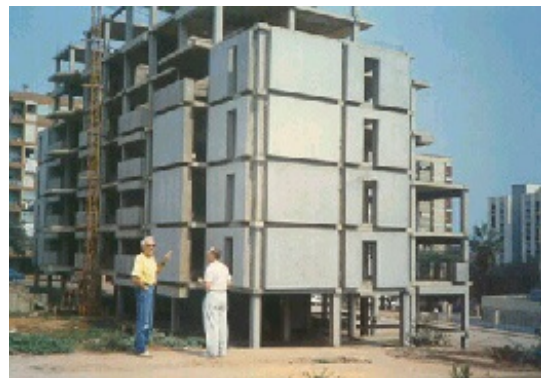
A building under construction, showing columns at the top floor erected in the vertical position

prefabrication can be carried out at the construction site. The erection is simple and fast, and it is carried out using erection equipment (cranes, etc.). Temporary support to the structural elements needs to be provided before permanent connection by prestressing is achieved. Before the prestressing is carried out, the space between the columns and horizontal elements (floor slabs, cantilever and edge girders) is filled with cement mortar (in order to enable transfer of axial forces). After the prestressing is completed, the holes in the columns are grouted with cement grout and the space between the adjacent floor slabs, cantilevers, or edge girders, is filled with concrete. In this way, the cables are protected from corrosion. Erection of concrete columns is shown in FIGURE 13. Examples of buildings of this type under construction are shown in FIGURE 5, FIGURE 10, FIGURE 11 and FIGURE 12. The construction of this type of housing takes place in a single phase. Typically, the building is originally designed for its final constructed size.

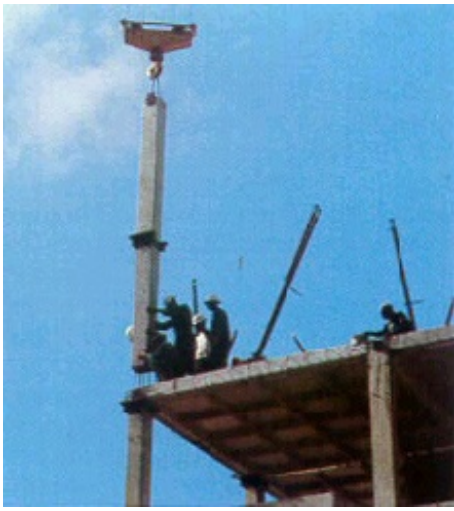
An Illustration of column erection
